## Queen Elizabeth's Girls School

### Problem

### Solution

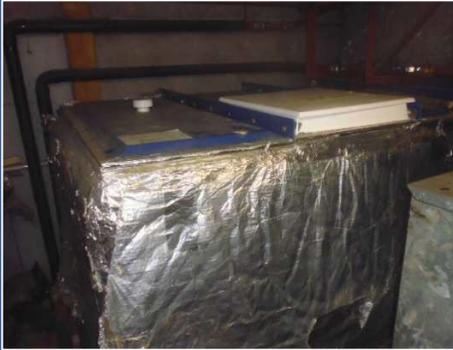
We carried out a more detailed survey and established that the galv tank had previously rusted and been fitted with a butyl rubber lining some time ago.

It is not known when this alteration occurred but, as often happens with these linings, over time it had degraded and started to fall away from the walls and break apart. As well as stagnant water gathering between the lining and the tank walls, the lining was also breaking off and causing the down-services to become blocked, thereby negatively affecting the flow to the outlets throughout the building.

**Before** - internal photograph shows butyl lining being removed and the full extent of the corrosion beneath on the galv surfaces

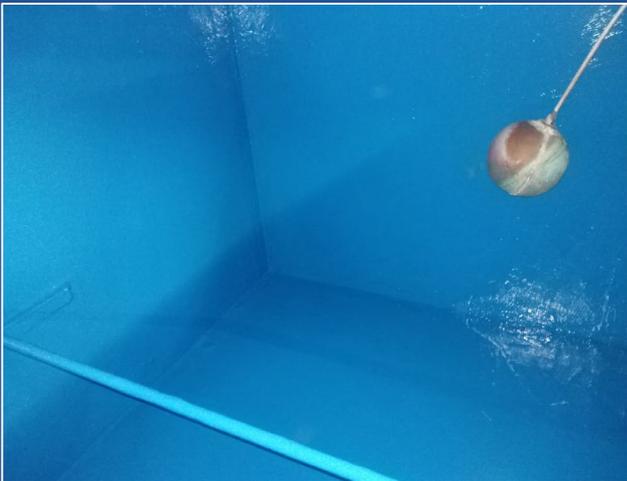
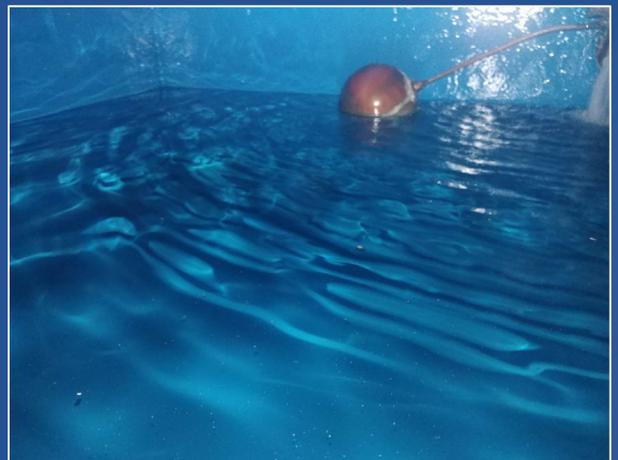
**After** - before and after filling and disinfection

Isolate and drain down tank.

Manually abrade internal surfaces tank.

Remove all debris and thoroughly dry, in preparation for painting.

Apply first coat of Cotex 3, two part solvent free Polyurethane paint to all internal Surfaces. Allow to cure and apply second coat of paint (blue).

On completion disinfect with a solution of "HuwaSan TR50", a stabilised solution of hydrogen peroxide and silver salts at 150ppm to give a hydrogen peroxide content of 75ppm and silver ion content of 50-70ppb.
