Queen Elizabeth's Girls School

We have a service contract at Queen Elizabeth's Girls School in Barnet to undertake temperature monitoring and carry out additional tasks including TMV and showerhead servicing - all part of their water hygiene programme.

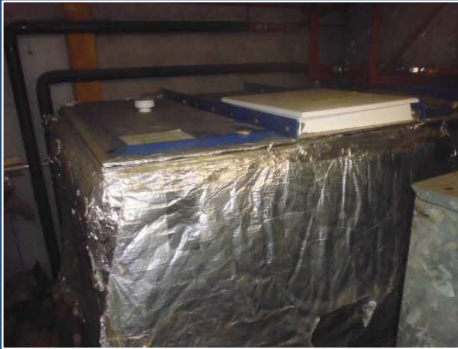
We carried out a more detailed survey and established that the galv tank had previously rusted and been fitted with a butyl rubber lining some time ago.

It is not known when this alteration occurred but, as often happens with these linings, over time it had degraded and started to fall away from the walls and break apart. As well as stagnant water gathering between the lining and the tank walls, the lining was also breaking off and causing the down-services to become blocked, thereby negatively affecting the flow to the outlets throughout the building.

Before - internal photograph shows butyl lining being removed and the full extent of the corrosion beneath on the galv surfaces

Following our swift site visit we submitted a proposal to remove the existing lining, and prepare the corroded surfaces of the tank ready for the application of a 2-coat Polyurethane-based paint system in order to extend the life of the tank and eradicate the blockages.

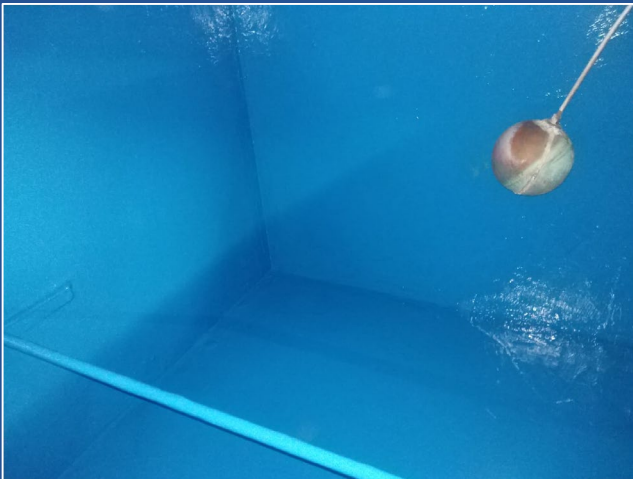
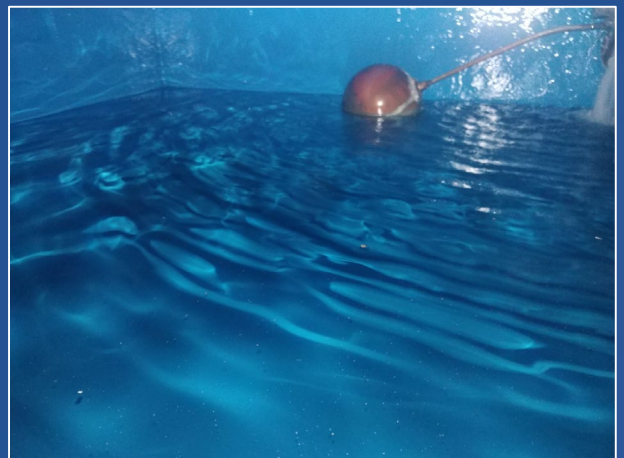
After - before and after filling and disinfection

Apply first coat of Cotex 3, two part solvent free Polyurethane paint to all internal Surfaces. Allow to cure and apply second coat of paint (blue).

On completion disinfect with a solution of "HuwaSan TR50", a stabilised solution of hydrogen peroxide and silver salts at 150ppm to give a hydrogen peroxide content of 75ppm and silver ion content of 50-70ppb.
