Figure 2.12 Cold water storage tank inspection

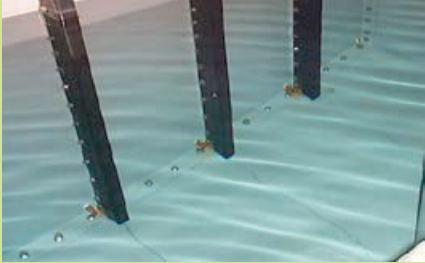
Clean tank but with slight corrosion on bolts	Light debris but corrosion to restraining bars

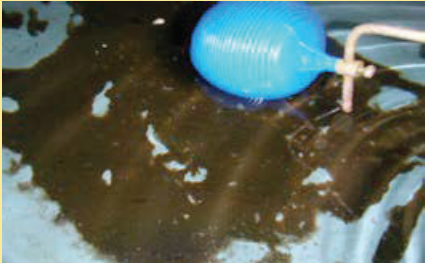
Moderate fouling suggesting cleaning should be conducted during the next 12 months	Slight to moderate level of debris, tank cleaning should be planned. Hollow tube supports should also no longer be used – see EFA/2013/004 at www.dhsspsni.gov.uk/efa-2013-004.pdf

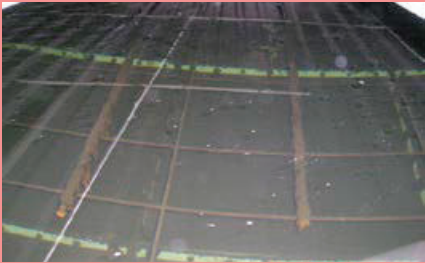
Heavy debris and corrosion of internal parts that will require remedial works	Severe stagnation could indicate that the tank is oversized, or not being used

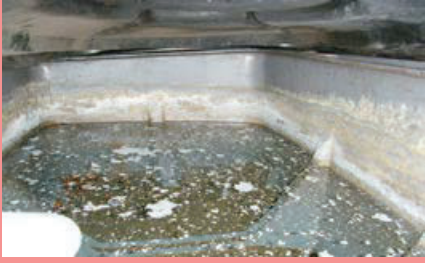
Unusually heavy scale formation requiring more than a regular clean and disinfection	Gel coat (glass reinforced plastic) failure resulting in local biological fouling (dark spots)
