Heathfield Gardens

Case Study

005

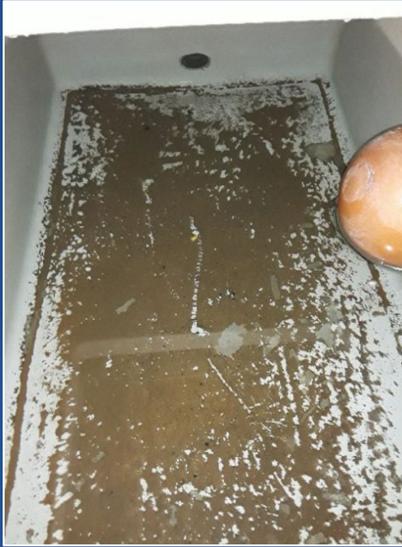
The large GRP tank at Heathfield Gardens is located in a cramped loft space where access is difficult. Internal and external surveying demonstrated that the tank was compliant with regulations, however, there was a build up of sediment on the base of the tank – which can provide nutrients for harmful bacteria or act as a breeding ground – so we recommended immediate cleaning and disinfection.

Tank internal – Before cleaning

Using modern cleaning equipment our engineers cleaned the tank and disinfected upon completion using sodium hypochlorite before reinstating – see before and after pictures on page 2.

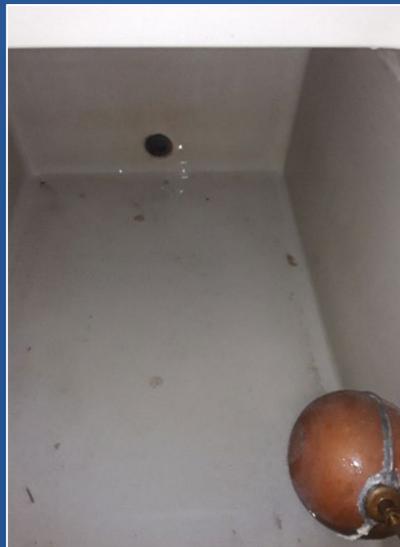
Tank internal – After cleaning

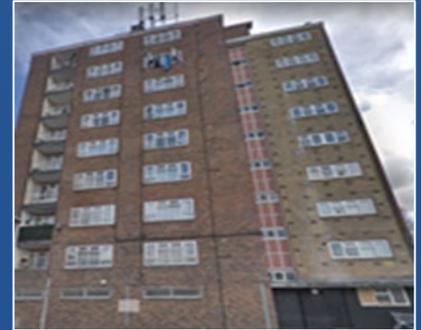
Examples of our tablet generated tank survey and disinfection reports completed at Heathfield Gardens (above)

TANK SURVEY REPORT		goodwater
Condition of insulation (outside pipework):	Good	
Temperature of make-up water at ball valve (<20°C):	9.6	
Temperature of water in tank remote from ball valve (>20°C):	9.6	
Condition of ball valve:	Good	
Stagnation (inside tank):	None present	
Sliming or algae (inside tank):	None present	
Microbiological fouling (inside tank):	None present	
Corrosion (inside tank):	None present	
Debris (inside tank):	None present	
Scale (inside tank):	None present	
Comments		
Comments:		* Tank complies with Water Supply (Water Quality) Regulations 2000/HSG274 - No action required.

SYSTEM DISINFECTION REPORT		goodwater	
Customer:	London Borough of Croydon	Visit:	One-Off / Supply of Goods
Contract:	SDR37771	Engineer:	Mike Fearn (gw0022)
Site:	46-76 Heathfield Gardens (46-)	Date:	25 Feb 2019 12:24
Building Reference			
Building site:	46-76 Heathfield Gardens		
Area:	Loft space tank room		
Disinfection Details			
Services treated:	* Storage tanks		
Chemical used:	Sodium Hypochlorite		
Contact period (hrs):	1		
pH:	0		
Chemical concentration during disinfection (ppm):	60		
Chemical concentration at end of contact period (ppm):	60		
Chemical concentration upon completion of disinfection process (ppm):	0		
TANKS cleaned?	Yes		
Samples taken?	N/A		
Comments, Recommendations and Actions Required			
General comments: * Disinfection works undertaken successfully. No further action required.			
Photographs			
Tank 1 - pre-clean			
Date:	06/11/2019 16:01
