Case Study

008

NHS Hospital

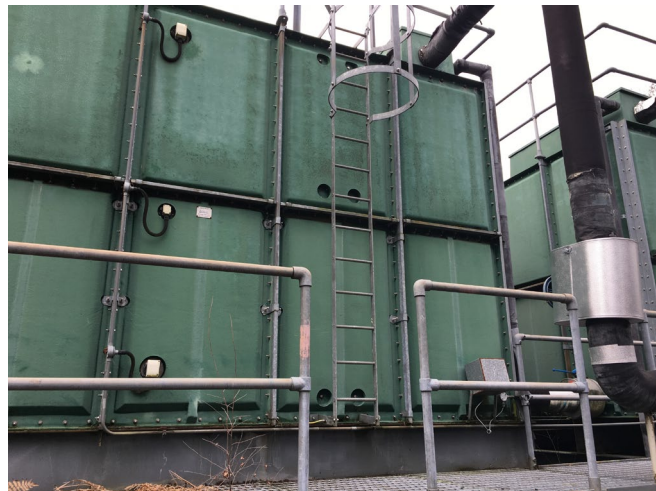
External view of Tank 1

It was reported that the 2 No. 20,000 lts CWS tanks had hollow supports and the tank also contained debris and so required cleaning. Both of these issues, if not dealt with, can promote the proliferation of bacteria leading to infection and place the building's occupants at risk.

Each tank was drained to carry out the remedial work to the supports, and all dirt and debris was removed using an aquavac.

On completion they were re-filled with clean water and a solution of Sodium Hypochlorite was introduced to give a free residual chlorine concentration of 50ppm, ensuring a thorough mix throughout.

On completion of the contact period the chlorinated water within the tanks was neutralised with Sodium Thiosulphate, drained again and re-filled ensuring all traces of the neutralising agent were completely removed.

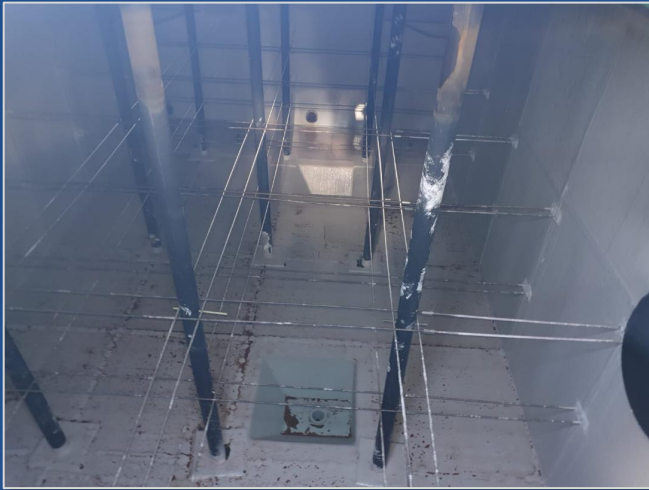
Tank 1

BEFORE ❌

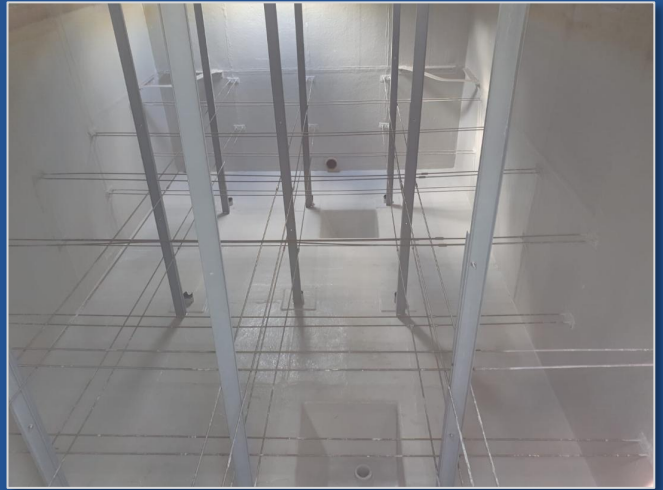
AFTER ✅
