Service Station, Buckinghamshire

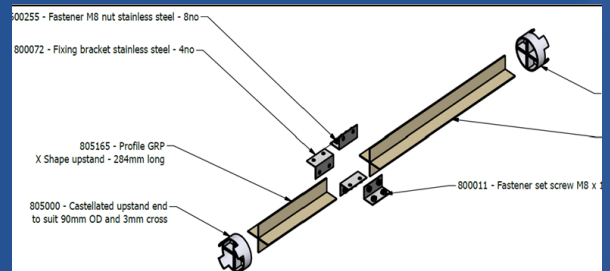
X-profile solid tank support system

The solution therefore was simple and the client took us up on our recommendations. Our advice was to drain the tanks and remove the offending articles, replacing them with fully approved and compliant X-profile GRP upright supports.
