Heathfield Gardens

Since early 2015 we have been working alongside the London Borough of Croydon Council undertaking a variety of water hygiene works in their sheltered housing sites and residential housing blocks.

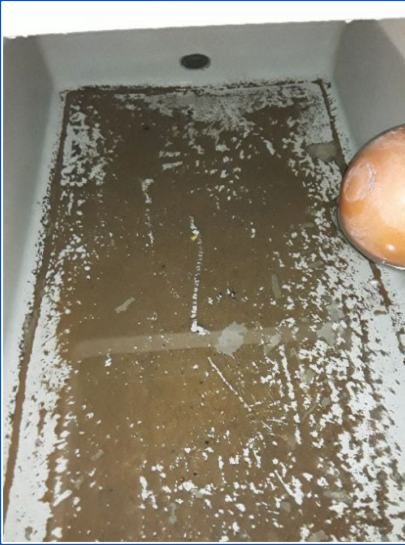
The large GRP tank at Heathfield Gardens is located in a cramped loft space where access is difficult. Internal and external surveying demonstrated that the tank was compliant with regulations, however, there was a build up of sediment on the base of the tank - which can provide nutrients for harmful bacteria or act as a breeding ground - so we recommended immediate cleaning and disinfection.

Tank internal – Before cleaning

Using modern cleaning equipment our engineers cleaned the tank and disinfected upon completion using sodium hypochlorite before reinstating – see before and after pictures on page 2.

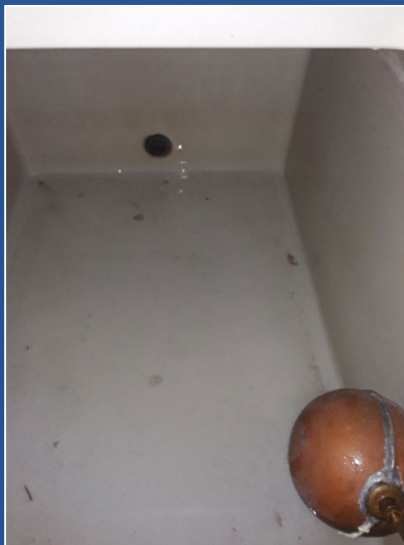
Tank internal – After cleaning

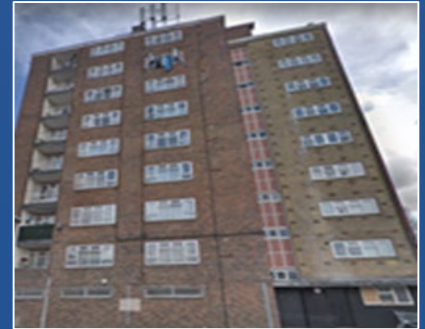
Examples of our tablet generated tank survey and disinfection reports completed at Heathfield Gardens (above)

TANK SURVEY REPORT		goodwater
Condition of insulation (outside pipework):	Good	
Temperature of make-up water at ball valve (<20°C):	9.6	
Temperature of water in tank remote from ball valve (>20°C):	9.6	
Condition of ball-valve:	Good	
Stagnation (inside tank):	None present	
Sliming or algae (inside tank):	None present	
Microbiological fouling (inside tank):	None present	
Corrosion (inside tank):	None present	
Debris (inside tank):	None present	
Scale (inside tank):	None present	
Comments:	* Tank complies with Water Supply (Water Quality) Regulations 2000/HSG274 - No action required.

SYSTEM DISINFECTION REPORT				goodwater
Customer:	London Borough of Croydon	Visit:	One-off / Supply of Goods	
Contract:	SDR3771	Engineer:	Mike Fearn (gw0022)	
Site:	46-76 Heathfield Gardens (46-)	Date:	25 Feb 2019 12:24	
Building Reference				
Building/site:	46-76 Heathfield Gardens			
Area:	Loft space tank room			
Disinfection Details				
Services treated:	* Storage tanks			
Chemical used:	Sodium Hypochlorite			
Contact period (hrs):	1			
pH:	0			
Chemical concentration during disinfection (ppm):	60			
Chemical concentration at end of contact period (ppm):	60			
Chemical concentration upon completion of disinfection process (ppm):	0			
TANKS cleaned?	Yes			
Samples taken?	N/A			
Comments, Recommendations and Actions Required				
General comments:	* Disinfection works undertaken successfully. No further action required.			
Photographs				
Date:	06/11/2019 16:01
