Chalfont Business Park

After being abandoned during COVID, our customer called us in to look at a large water feature (measuring 80m long, 2m wide and 400mm water depth) which, after such a long time had essentially turned into a pond.

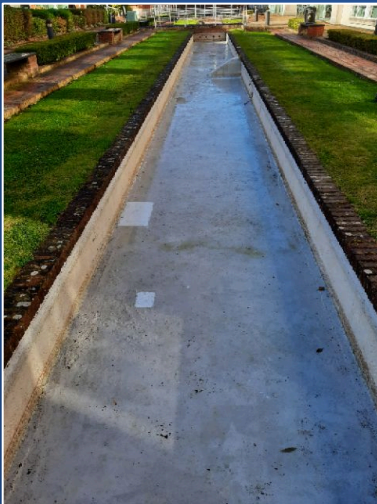
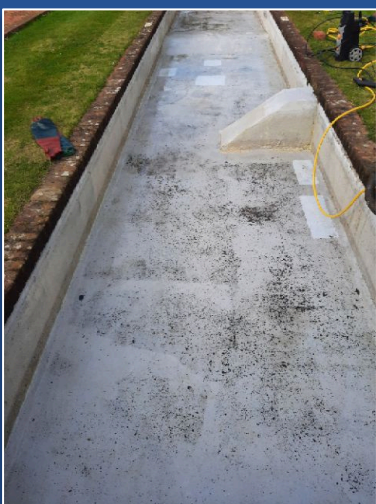
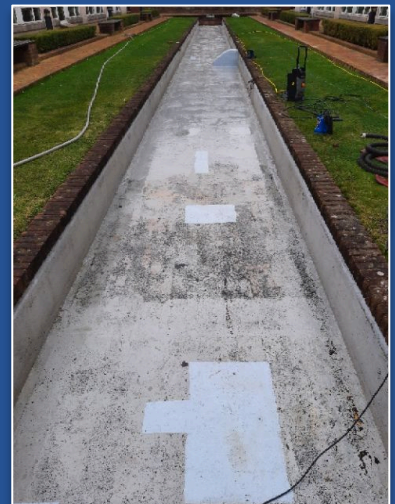
After

The water feature looks in great condition again and the customer is very pleased with the result.
