## Queen Elizabeth's Girls School

### Problem

### Solution

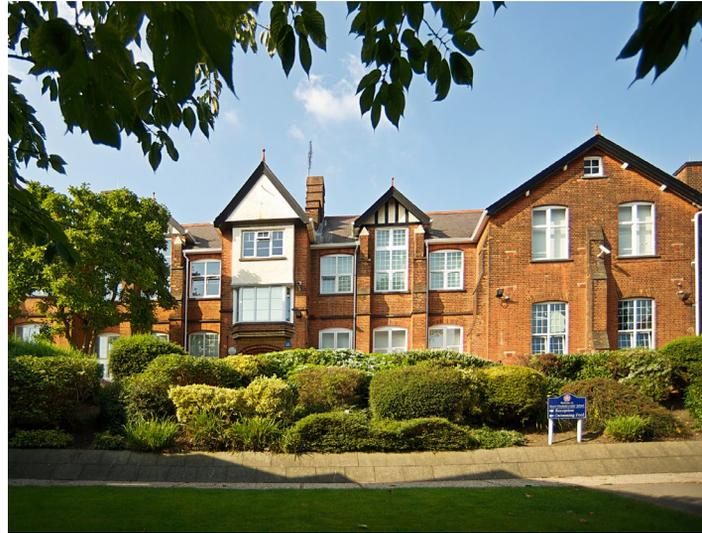
A survey of the domestic water services revealed that the flow issues were due to a blockage at the cold water tank.

We carried out a more detailed survey and established that the galv tank had previously rusted and been fitted with a butyl rubber lining some time ago.

It is not known when this alteration occurred but, as often happens with these linings, over time it had degraded and started to fall away from the walls and break apart. As well as stagnant water gathering between the lining and the tank walls, the lining was also breaking off and causing the down-services to become blocked, thereby negatively affecting the flow to the outlets throughout the building.

Following our swift site visit we submitted a proposal to remove the existing lining, and prepare the corroded surfaces of the tank ready for the application of a 2-coat Polyurethane-based paint system in order to extend the life of the tank and eradicate the blockages.

Within days an order was received and our operatives were on site over a weekend, addressing the issue, and on completion of the lining process, the tank was fully disinfected and then brought back into service allowing the school to proceed with their open evening event as planned.
