Queen Elizabeth's Girls School

We have a service contract at Queen Elizabeth's Girls School in Barnet to undertake temperature monitoring and carry out additional tasks including TMV and showerhead servicing - all part of their water hygiene programme.

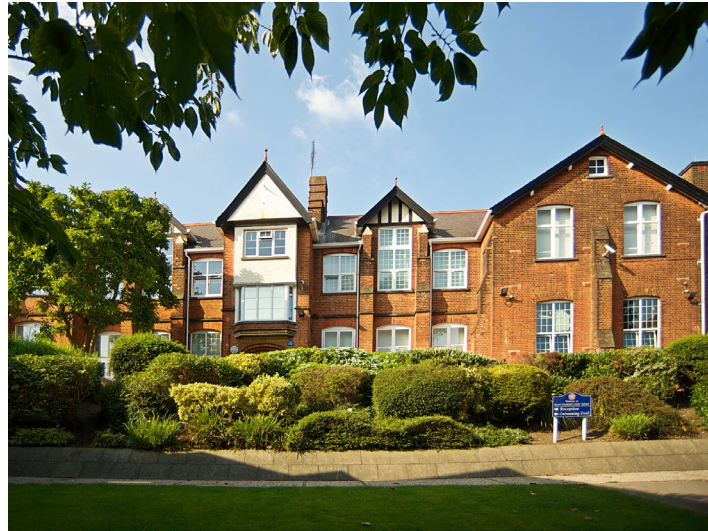
We carried out a more detailed survey and established that the galv tank had previously rusted and been fitted with a butyl rubber lining some time ago.

It is not known when this alteration occurred but, as often happens with these linings, over time it had degraded and started to fall away from the walls and break apart. As well as stagnant water gathering between the lining and the tank walls, the lining was also breaking off and causing the down-services to become blocked, thereby negatively affecting the flow to the outlets throughout the building.

Following our swift site visit we submitted a proposal to remove the existing lining, and prepare the corroded surfaces of the tank ready for the application of a 2-coat Polyurethane-based paint system in order to extend the life of the tank and eradicate the blockages.

Within days an order was received and our operatives were on site over a weekend, addressing the issue, and on completion of the lining process, the tank was fully disinfected and then brought back into service allowing the school to proceed with their open evening event as planned.

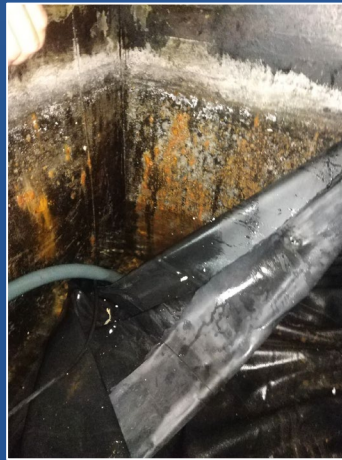
Before - internal photograph shows butyl lining being removed and the full extent of the corrosion beneath on the galv surfaces

Isolate and drain down tank.
