**The RAM Quarter is an award-winning new development in the heart of Wandsworth, SW18 combining residential spaces with cafés, bars, restaurants, a cinema and other entertainment, a riverside walk, and a Heritage Centre celebrating the site's special brewing past.**

**It is a real community and a thriving retail area and we are lucky to work there on behalf of Vital Energi undertaking annual tank cleaning and disinfection.**

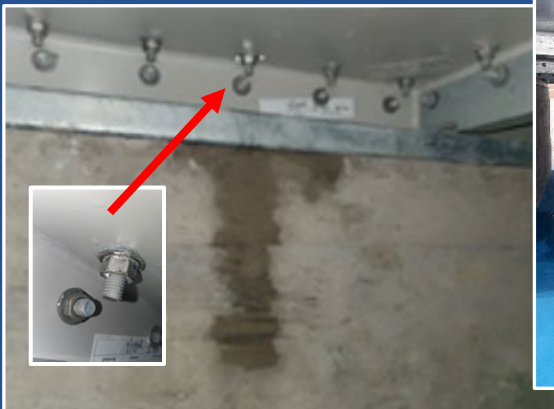
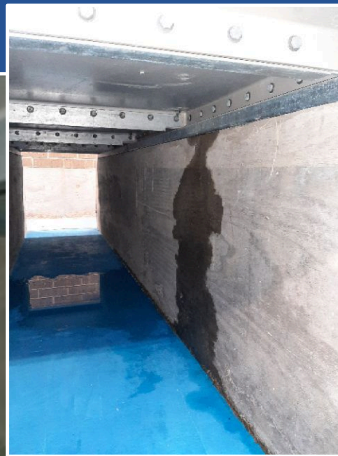
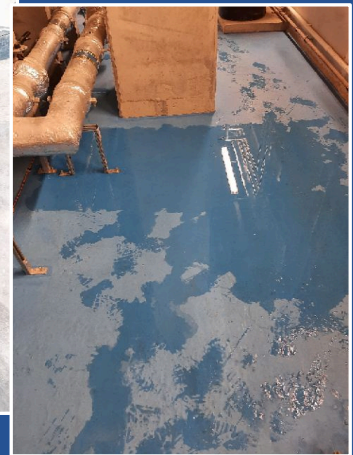
### Water damage

Whilst on site our engineers observed that one of the ball-valves was faulty, and several days after the process we received a call to say that there was a leak from the bottom of Tank 1.

There had been a faulty bolt which was allowing water to seep out into the plant areas, and whilst not a problem we had caused we took responsibility to effect a repair, refitting the bolt and ensuring the tank was left water tight again.

As for the leak – once we were notified we arranged to attend site to address the problem out of hours, and within a matter of days everything was fixed.
