Avante – Parkview Care Home

Parkview care home, located in Bexleyheath on the outskirts of London, is part of the Avante group of sites which provides a wealth of support services for people living with dementia.

Problem

Solution

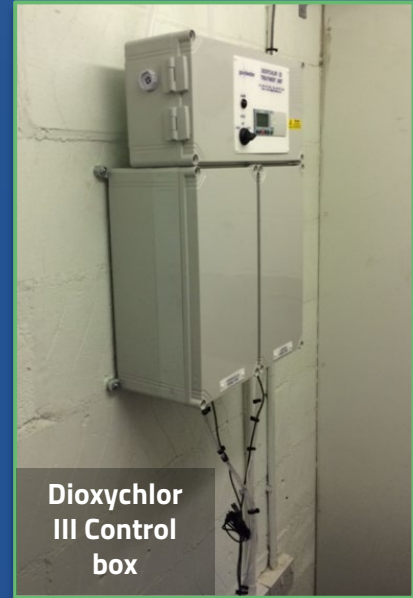
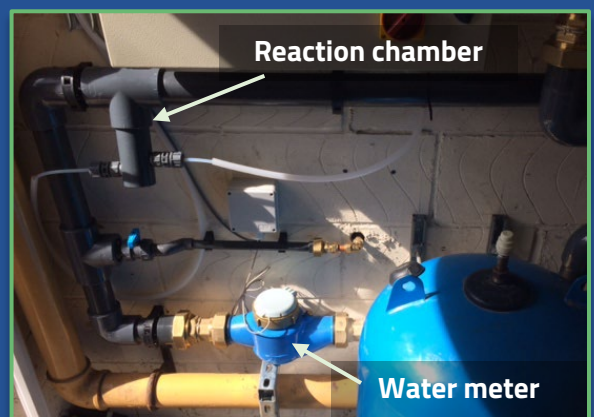
We proposed chlorine dioxide treatment and, after initial positive discussions, one of our **Dorado** range Dioxychlor III chlorine dioxide units was ordered for supply and install at Parkview Care Home.

After successful installation, the chlorine dioxide levels were monitored very closely for the next few months and Legionella samples were taken on each visit (weekly initially and then monthly thereafter) to prove the efficacy. The chlorine dioxide had soon broken down any biofilm potentially in the system, and we had several consecutive months of samples without any detection of Legionella.

At the point at which the system was under control via chlorine dioxide, and after confirming with the client that they did not class themselves as NHS Healthcare and did not need to follow the HTMs, site then started gradually reducing the hot water temperatures (by 5°C or so) from around 65°C at the calorifier to roughly 45°C over the course of a few months. We continued to take samples each month to ensure that control of the system was being maintained.

Since then, we have maintained control of the system using chlorine dioxide and taking regular Legionella samples. We have used chlorine dioxide as the primary control measure where temperature control is not as effective. It has also meant the client has been able to reduce HWS temperatures. Ideally you would use both temperature control and chlorine dioxide but where temperature control may not be as effective, such as in this case, then the use of the chlorine dioxide is more cost effective and energy efficient as the water in the calorifiers is not stored at 60°C. It also means you can eliminate the use of TMVs (thermostatic mixing valves) to prevent scalding, which require costly maintenance etc, as the HWS temperatures are lower and are not providing any risk of scalding.
